Name Of Dam: SWIFT CREEK RESERVOIR DAM  
Location: CHESTERFIELD COUNTY  
Inventory Number: VA. 04112

# PHASE I INSPECTION REPORT

## NATIONAL DAM SAFETY PROGRAM

**DEWARD M. MARTIN & ASSOCIATES  
WILLIAMSBURG, VIRGINIA  
AUGUST, 1979**

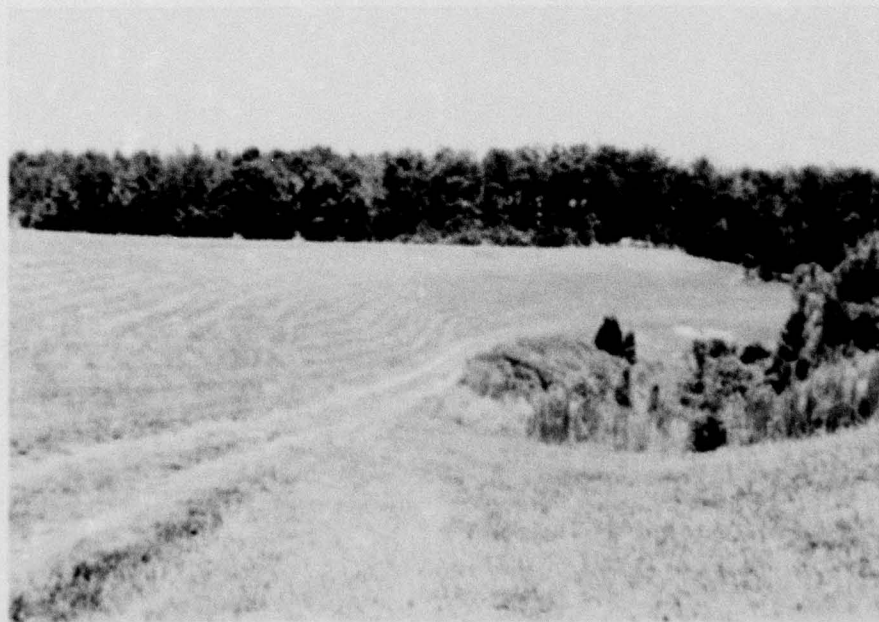
Downstream Face of Dam

3.1.2 Dam: The embankment appears to be in good condition, however, some surface erosion was noted on the downstream slope at the toe of the embankment, approximately 400 feet to the right of the left abutment (see Photograph of downstream face of the dam, Page iii.)

Seepage was observed adjacent to the 60-inch diameter outlet pipe and in the joints on the concrete spillway. The sealer in these joints has deteriorated to a large degree allowing moisture to seep through in several locations. Erosion was also detected in two areas on the downstream side of the embankment. These need remedial action.

\*7.2 Recommended and Remedial Measures: Action should be taken to determine whether the core is functioning and to determine the present stability of the dam. The evidence of seepage adjacent to the 60-inch diameter drain and around the left side of the spillway should be investigated so that remedial measures can be implemented. The sealer in the joints on the concrete spillway should be repaired as soon as possible and the areas of the embankment where erosion has occurred should be repaired and reseeded.

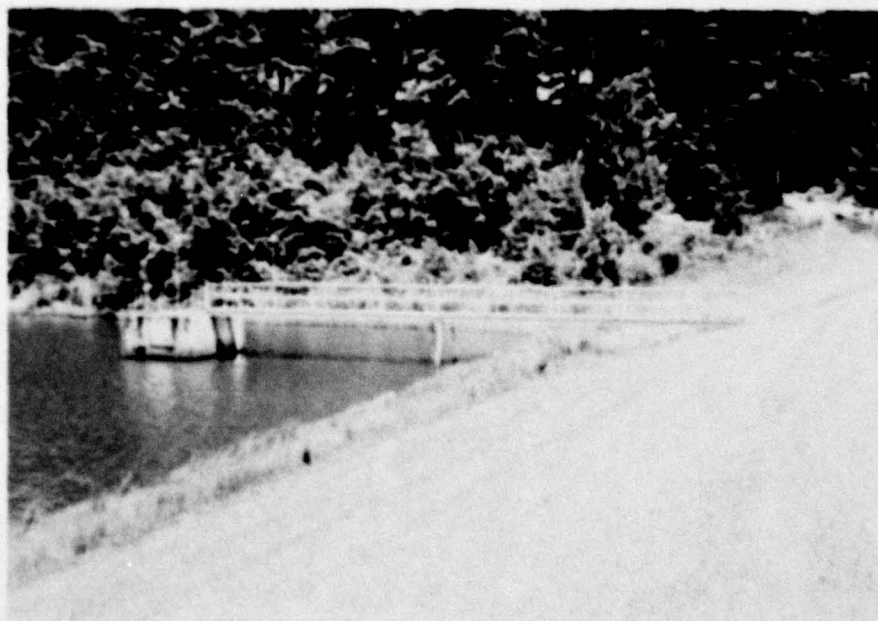
PHOTOGRAPH NO. 2  
Water Intake Tower

3.1.3 Appurtenant Structures: Observations of the intake tower indicated that it was in good condition. The four 24-inch headgates, used for supplying water to the treatment plant, and the 72-inch headgate, used to allow water to pass through the 60-inch diameter pipe, all appeared to be in good condition.

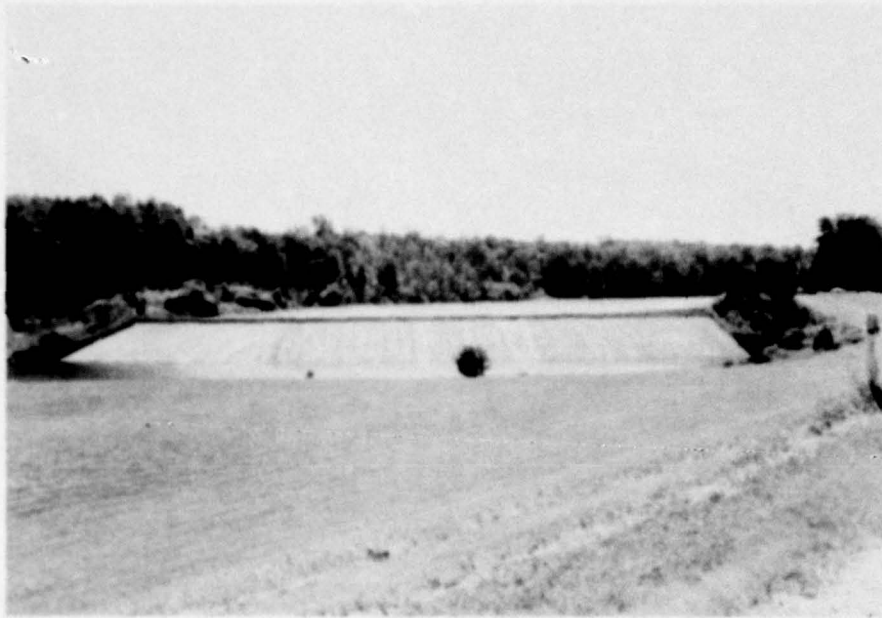
PHOTOGRAPH NO. 3  
Concrete Spillway

3.1.4 Spillway: The general condition of the concrete spillway surface was good although some small cracks were noted. The inspection also revealed some seepage in the concrete slab joints.

VISUAL EXAMINATION OF	OBSERVATIONS	REMARKS OR RECOMMENDATIONS
CONCRETE WEIR	The general condition of the concrete surface is good. There are several slight cracks and seepages on the spillway surfact resulting from deterioration of joint material.	
APPROACH CHANNEL	N/A	
DISCHARGE CHANNEL	A stilling basin below the spillway and a 620-foot outlet channel is connected to Swift Creek. Both are in good condition.	
BRIDGE AND PIERS	No cracks observed on the spillway endwalls.

3.2 Evaluation: The dam, in general, appears to be in good condition. It is recommended, however, that remedial action be taken to repair the sealer in the slab joints on the spillway. The areas of the embankment where erosion has occurred should be repaired and reseeded. The causes of the high phreatic surface as indicated by the reading of the observation wells should be investigated.

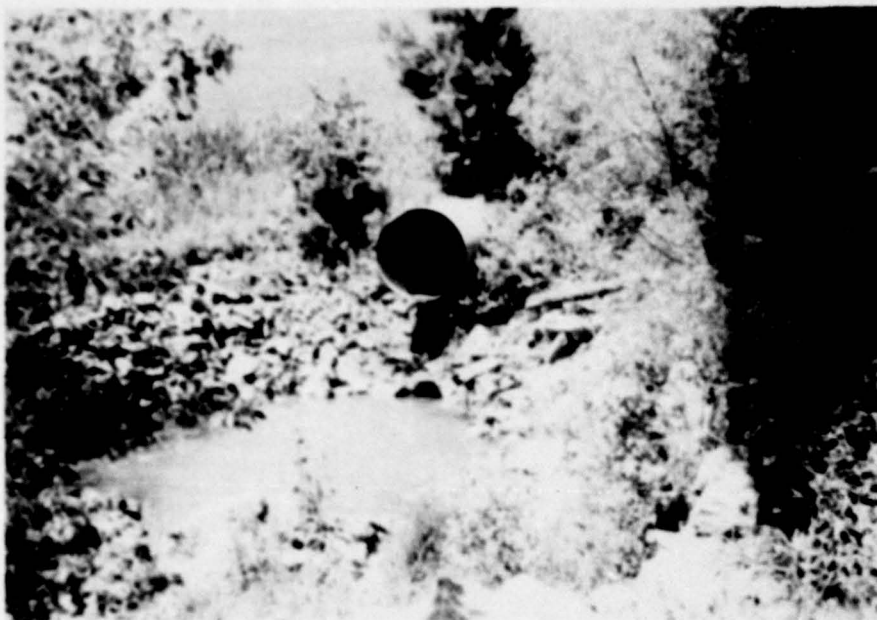
PHOTOGRAPH NO. 5  
60-inch Diameter Drain Outlet

\*Evidence of seepage, approximately 1 gpm, was observed adjacent to a 60-inch diameter drain located at the downstream toe of the dam. Marsh grass, cattails and saturated soils were observed adjacent to the pipe.

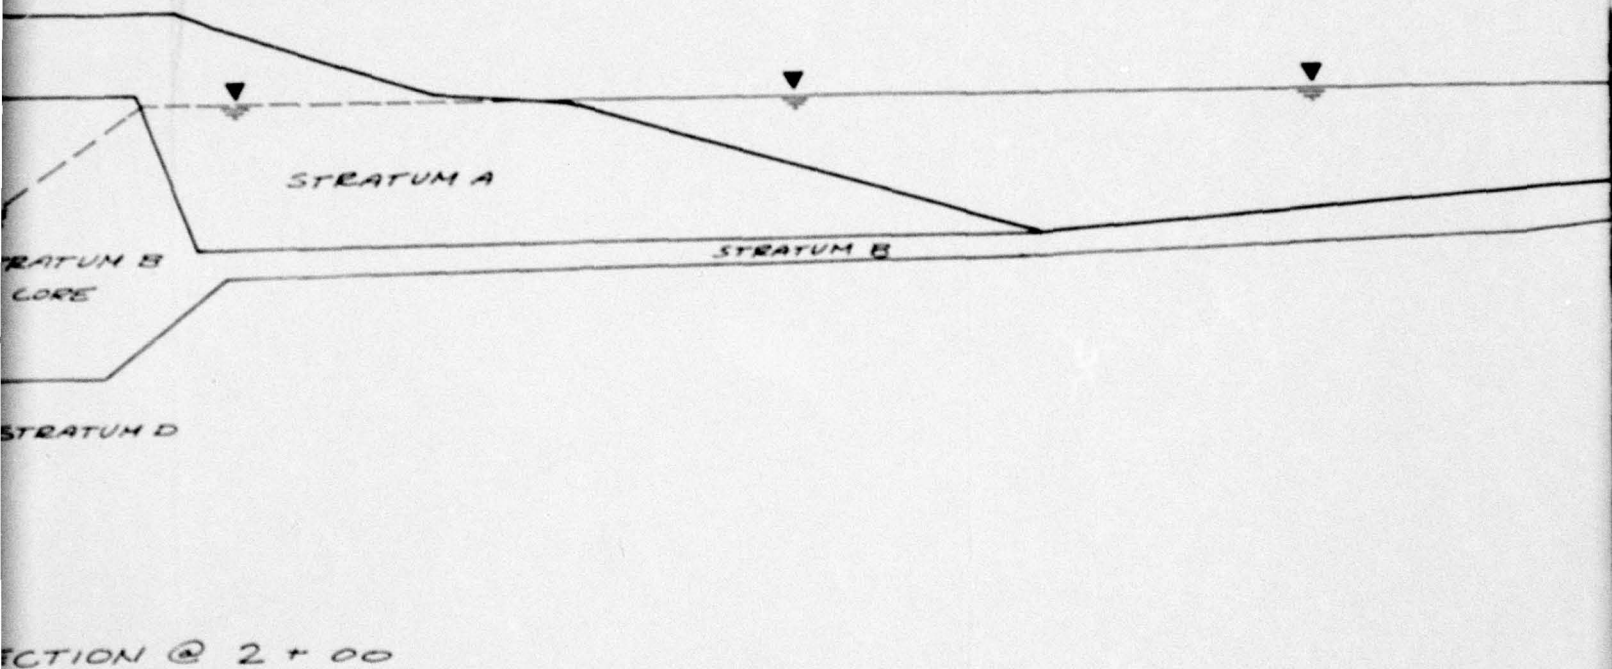
# PLATE NO. 1

\*7.1.2 From a geotechnical standpoint, the dam appears to be functioning well, with the exception of seepage conditions as noted in Section 3. In addition, the water level readings obtained on June 26, 1979 at two observation wells at the crest and downstream toe indicate either the core is not functioning properly or the pool had risen and seepage was occurring above the core. The higher line of seepage created by this condition makes the stability of the dam questionable.

\*7.2.1 It is recommended that the owner, at his own expense, secure the services of a professional engineer to monitor the seepage and phreatic levels to determine whether any further studies are necessary. The engineer should also make recommendations to corrective measures suggested in 7.2.

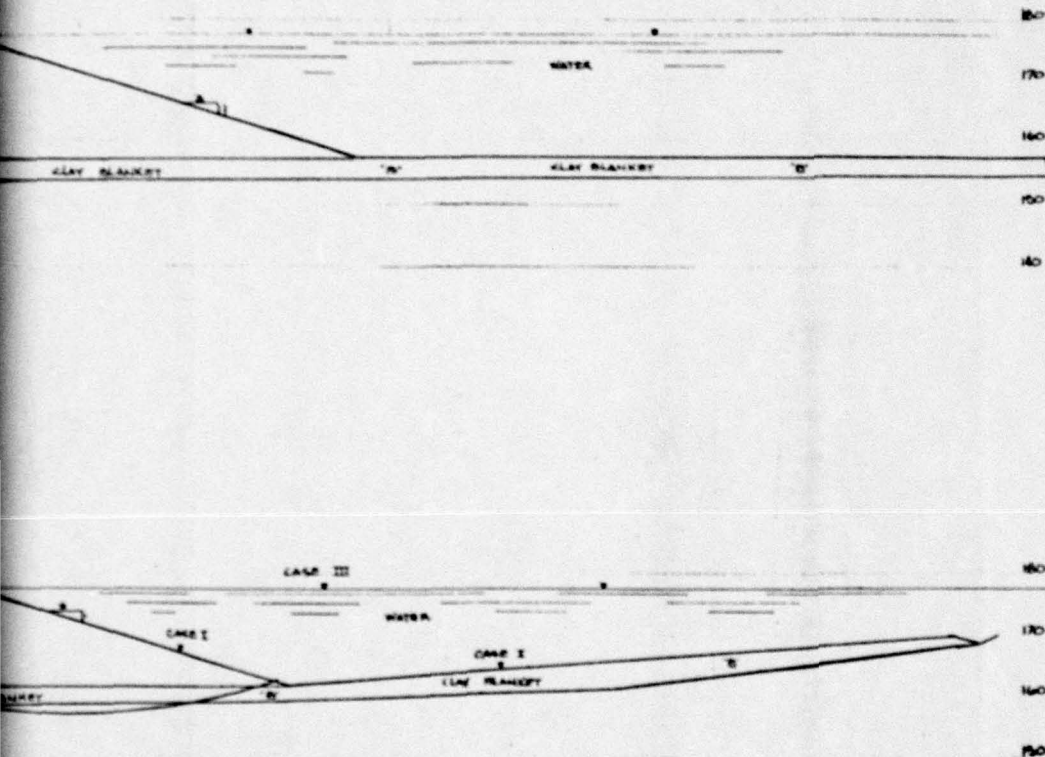
STABILITY	ANALYSIS
CASE I	FACTOR OF SAFETY
I	2.0
III	1.5

It should be noted in Drawing 3 that the critical failure circle for Case I loading conditions goes through Stratum D. There was no laboratory data presented for Stratum D and it is highly unlikely a critical failure would occur in this very dense material weathered rock rather than in the Stratum B soils (clay blanket) above it.
